Inspection Report

Minerals Regulatory Program

Mine Name: Seep Ridge

Permit number: M/047/002

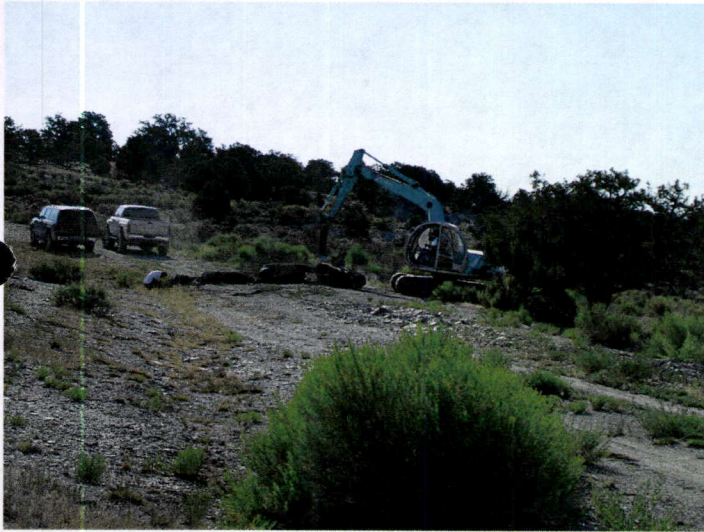
In 2002, the operator ripped several areas and seeded them. One of these areas was a road, and a culvert in the road was damaged to where it could damage someone's tire if they drove over it wrong. During the inspection, the trackhoe was used to pull out the culvert (Photo 1).

Photo 1. Digging the damaged culvert from the road.

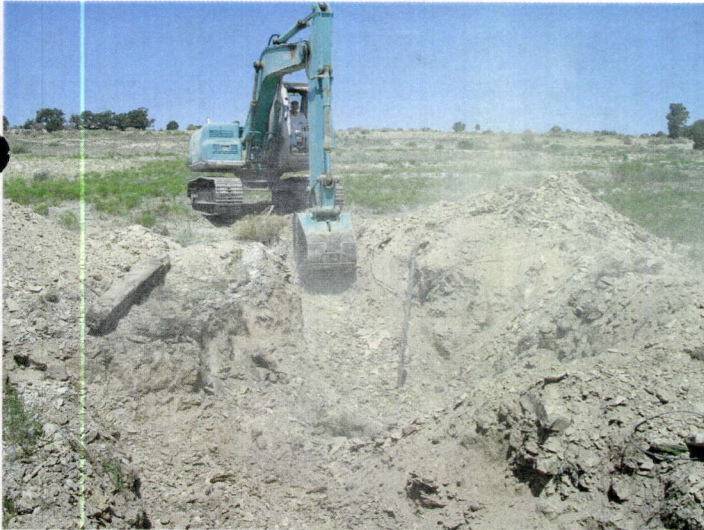
The trackhoe dug all around the galvanized pipe looking for any sign of the well or its casing (Photo 2). We did not find any casing. The pipe extended into bedrock with no sign of the casing (Photo 3), and the trackhoe was not able to dig any deeper. At this point, we decided to stop digging.

Photo 2. The trackhoe digging in the area of the galvanized pipe, looking for any sign of casing.

After returning to the office, I spoke with a person from Water Rights (I did not record and cannot remember his name) about what should be done. The chances of contaminating ground water are extremely remote, so he said the operator should cut the pipe below ground level then weld a steel plate on it. I understand this was done and that the excavation was filled back in.

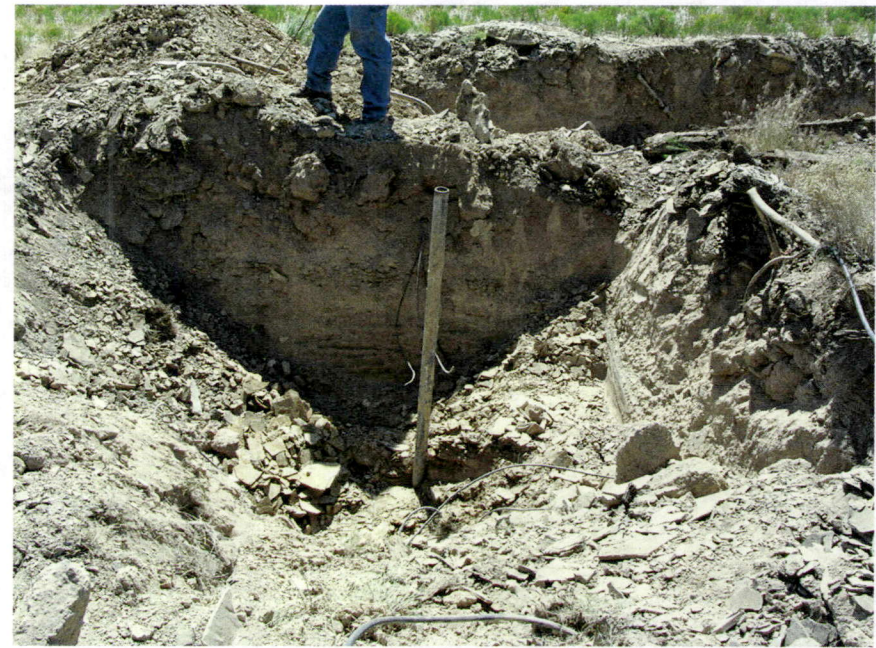
Photo 3. The galvanized pipe extends into bedrock with no sign of the well casing.
